FIRE RISK ASSESSMENT

**The Graham Care Group
Hawkhurst House
Hurricane Way
Hawkinge
CT18 7SS**

Date; 27th June 2022

Fire Risk Assessment
The Graham Care Group: Hawkhurst House
Date: 27th June 2022

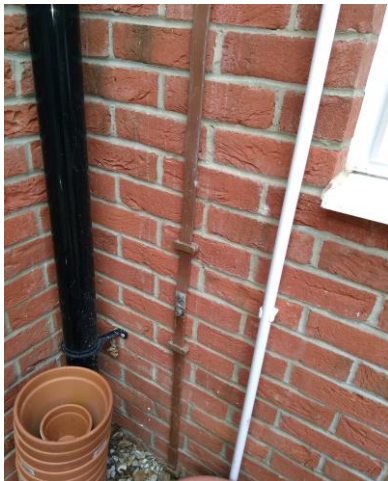
Picture 15

Lighting Protection		Lighting protection is provided for this building. See picture 15.	The lightning protection should be examined and tested at appropriate intervals by a competent person in accordance with the recommendations of British Standard 62305:2006.
