FIRE RISK ASSESSMENT

**The Graham Care Group
Hawkhurst House
Hurricane Way
Hawkinge
CT18 7SS**

Date; 27th June 2022

Fire Risk Assessment
The Graham Care Group: Hawkhurst House
Date: 27th June 2022

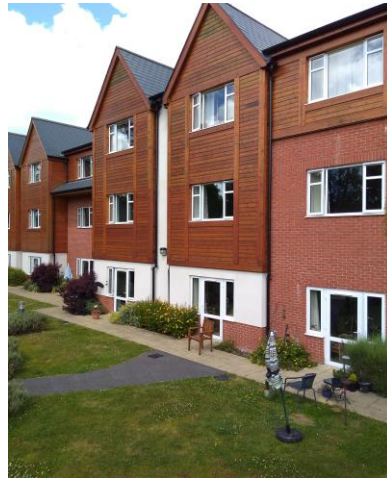
Picture 12

Limitations of Linings		Is it considered that there is reasonable limitation of linings that might promote fire spread?	Satisfactory
External Cladding	L	<p>It was identified at the time of inspection that the building did have external wooden cladding.</p> <p>See picture 12.</p>	External cladding was identified and a review and report utilising PAS 9980: 2022 should be conducted.

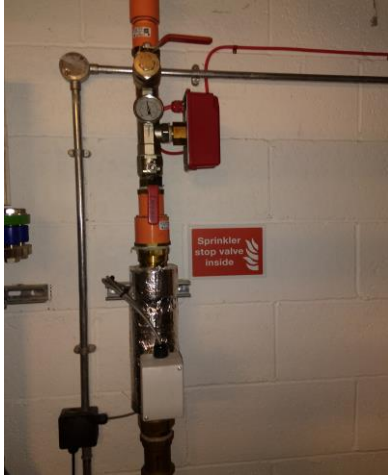
Picture 13

Manual Fire Extinguishing Appliances/Fixed Fire Fighting Systems			
Scope of Inspection	Risk	Details	Findings
Portable Fire Extinguishers		In order to allow staff to provide "first aid" fire fighting, Portable fire extinguishers and fire blankets have been provided in good condition and in sufficient quantities to satisfy the recommendations of BS5306.	Satisfactory
		Extinguishers are serviced in accordance with the current British Standard BS 5306: Part 3. The FFE was last serviced by Fire Action in November 2021.	Satisfactory
Relevant Automatic Fire Extinguishing Systems	L	<p>The premises is provided with the following fixed installations:</p> <p>Domestic sprinkler system throughout the building supplied via the towns mains. The shut off valve and mains feed is located in the basement plant room.</p> <p>It is believed to be a BS 9251:2014 Category 3 Sprinkler system. This includes larger residential care homes / nursing homes (with more than 10 residents) and also hostels. This category of residential sprinklers generally requires larger tank sizes of between 6m³ to 9m³ with storage for up to 30 minutes water supply. Calculations are based on 4 sprinklers heads operating and an average flow of 168-200 litres/minute.</p> <p>There was no information available at the time of inspection to confirm its exact specification.</p> <p>The pressure gauge indicated a pressure of 5.5 bar operating pressure.</p> <p>The system is serviced by Triangle.</p> <p>See picture 13.</p>	Information with regard to the sprinkler installation should held onsite.
