Health & Safety Inspection Report

Organisation	Graham Care Ltd, Hawkhurst House
Name(s) of Contact	Richard (Maintenance)
Address	Cranbrook Road, Hawkhurst, Kent, TN18 5EF
Tel No	01580 239170
E Mail	lewis@hawkhursthouse.com
Date of Inspection	26 th August 2020

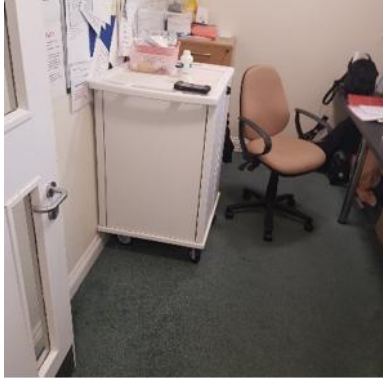
Observation	Recommendations	Responsibility	Completed	
Immediate Priorities. Resolve within 7 days.				
1	None identified			
High Priorities. Resolve within 1 month				
2	<p>An unattended drugs trolley was left in the office.</p>

<p>It is important to ensure the drugs trolley is secured at all times. This was in the Dementia unit and there is a risk a resident may access the drugs.</p>		
3	<p>The riser cupboard to the south end of the ground floor has gaps around the ventilation ducting.</p>

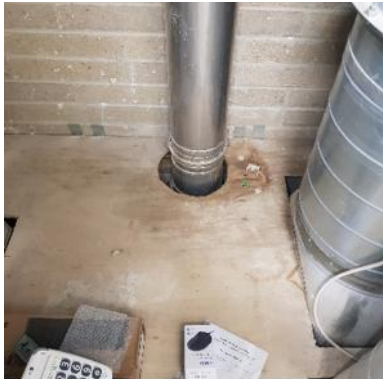
<p>The gaps are in the floor and ceiling area as shown in the photo. I am concerned that this may breach fire compartmentation. I recommend that you ask the fire risk assessor to take a view on this area and act according to his recommendations.</p>
